TEST REPORT
IEC 60068 Environmental Testing –
Part 2-1: Test A : Cold and
Part 2-78: Test Cab: Damp heat, steady state and
IEC 61373 Railway applications – Rolling stock equipment –
Shock and vibration tests

Report Number : **2407007**

Product name : AI Computing System

Model /Type reference..... : RCX-3750-PEG

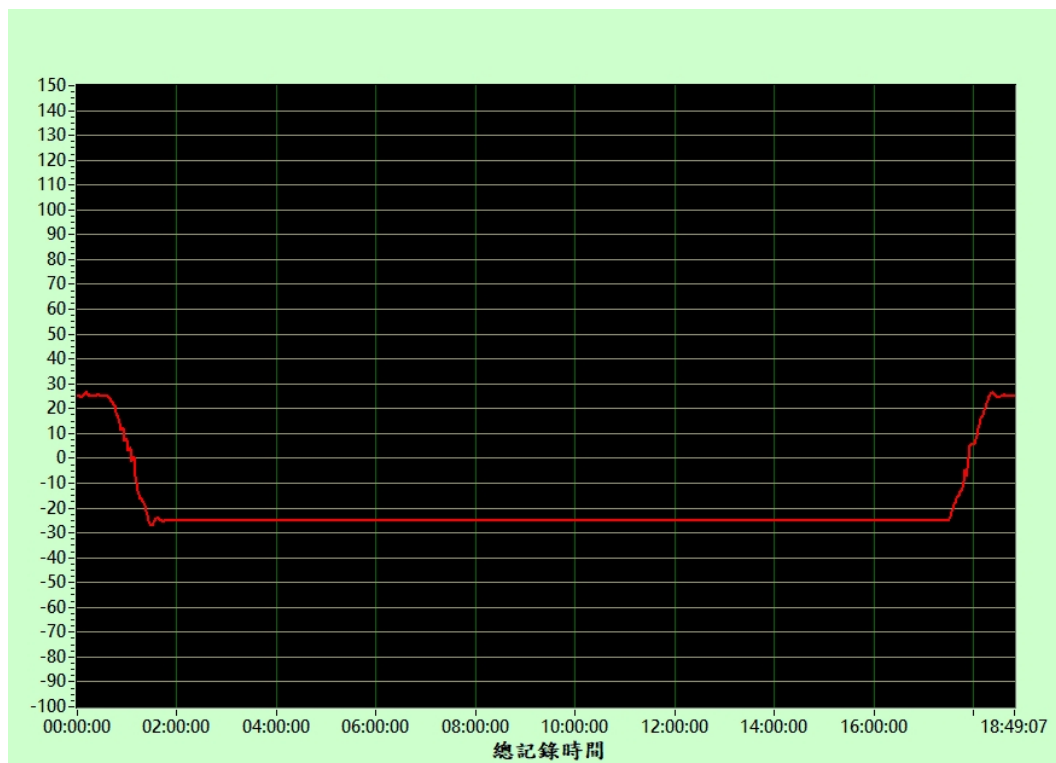
| TABLE: Low Temperature Test | | |
| Test temperature | Durations | Curve Chart |
| -25°C | 16hr | during testing |

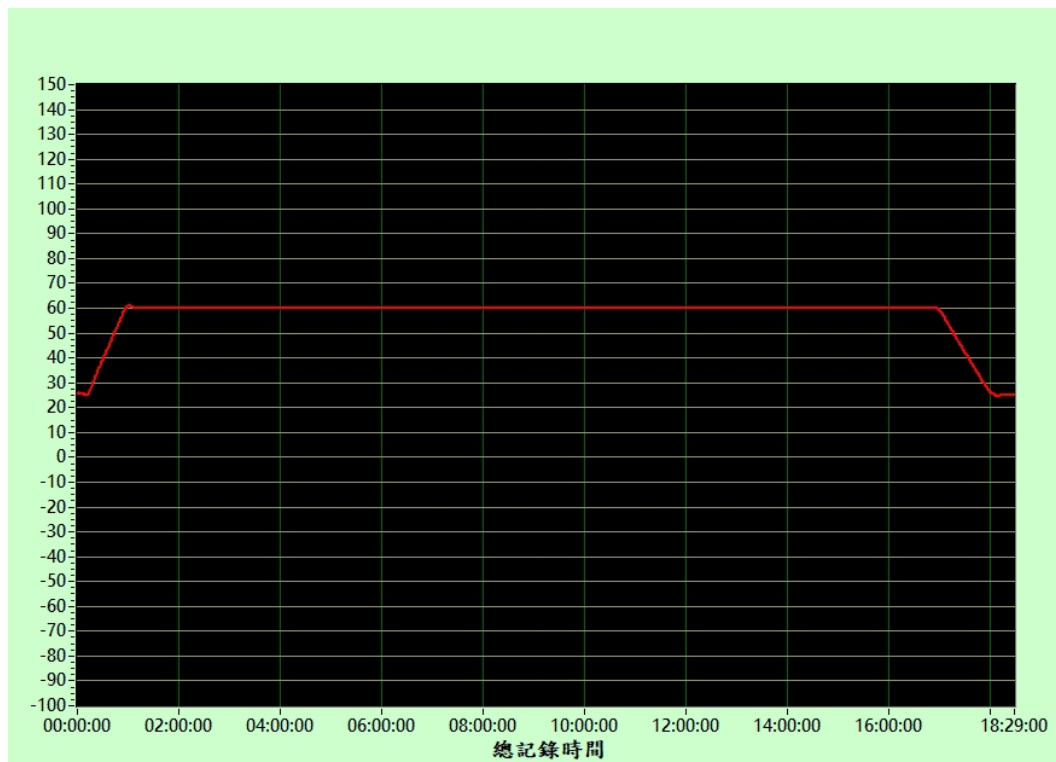
| TABLE: Damp Heat Test | | | |
| Test temperature | Test Humidity | Durations | Curve Chart |
| 60°C | 95% RH | 16hr | during testing |

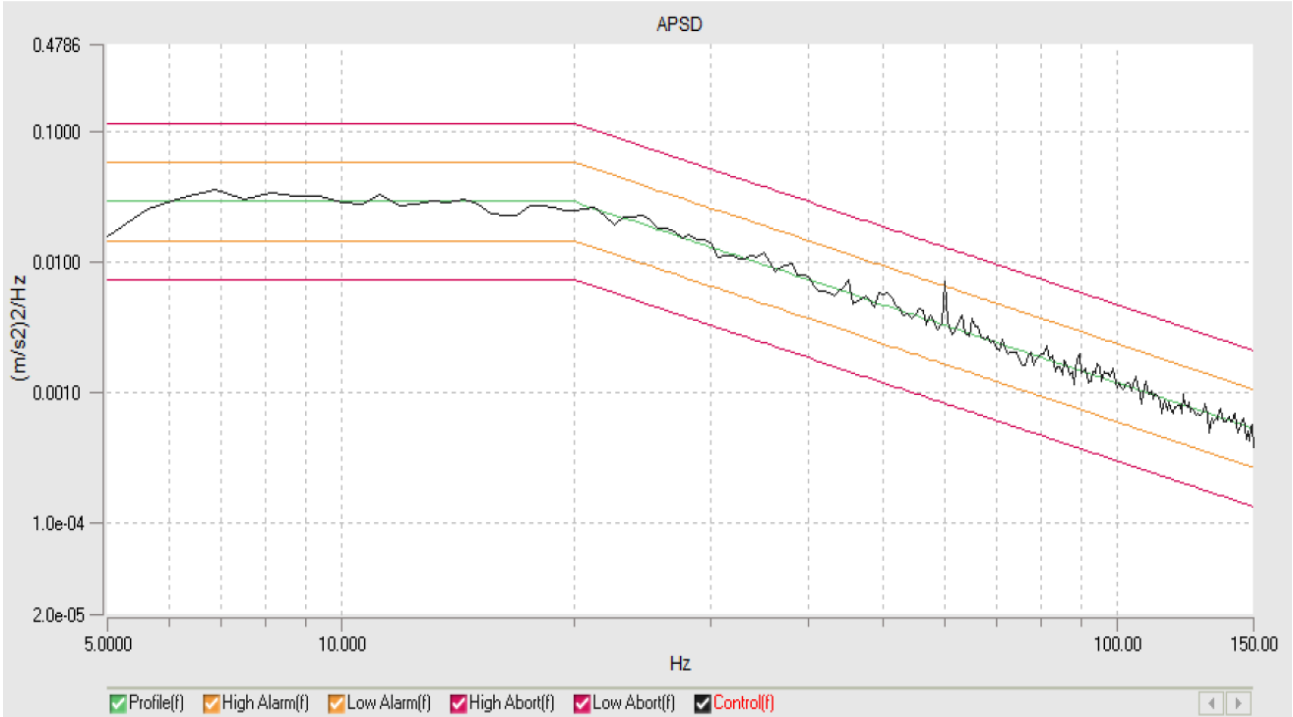
Vertical

| Test Equipment : | | | | | | | |
|--|---|---|---|---|---|---|--|
| Wave form: Random Wave | | | | | | | |
| Frequency: (5~150) Hz | | | | | | | |

TABLE: Vibration Test

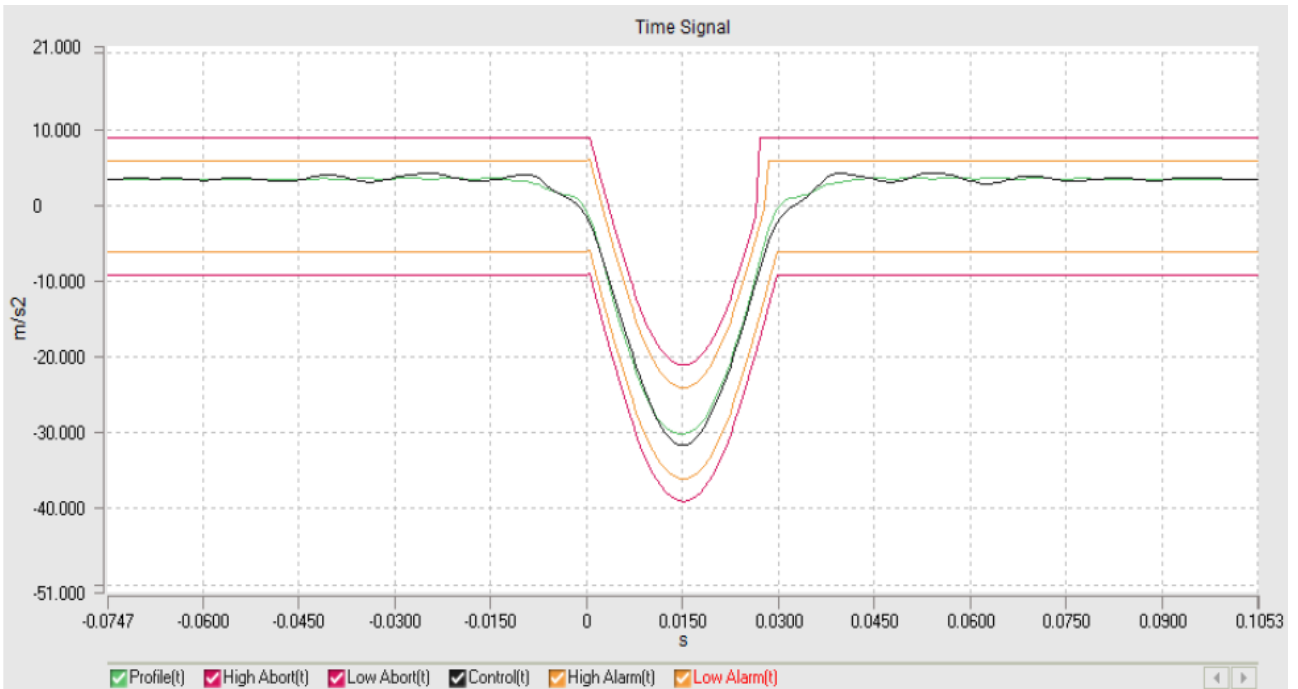
-X axis

| Test Equipment : | | | |
|--|---|---|---|
| IEC 61373 Edition 2.0: 2010 and client's request Pulse shape: Half-sine Acceleration: Vertical: 3g Transverse: 3g Longitudinal: 5g Pulse duration: 30 ms Shock direction: ±x, ±Y, ±Z axes No. of shock: 3 shocks/ axis (total 6 shocks) | | | |

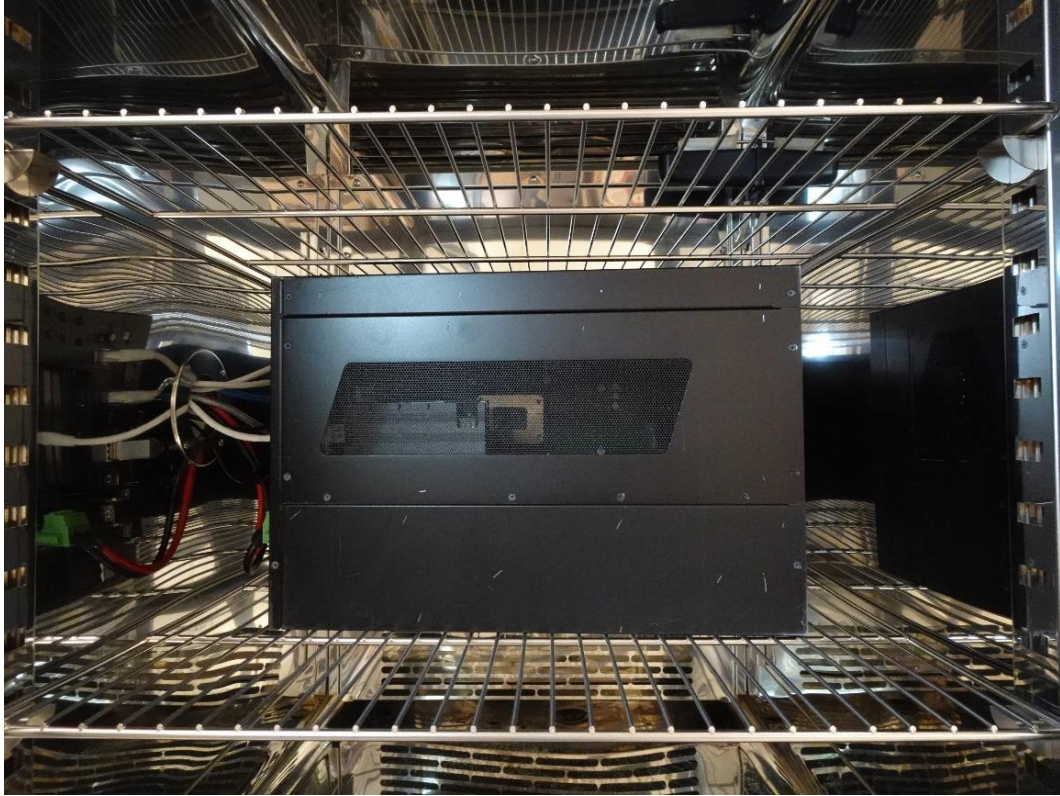
During temperture test

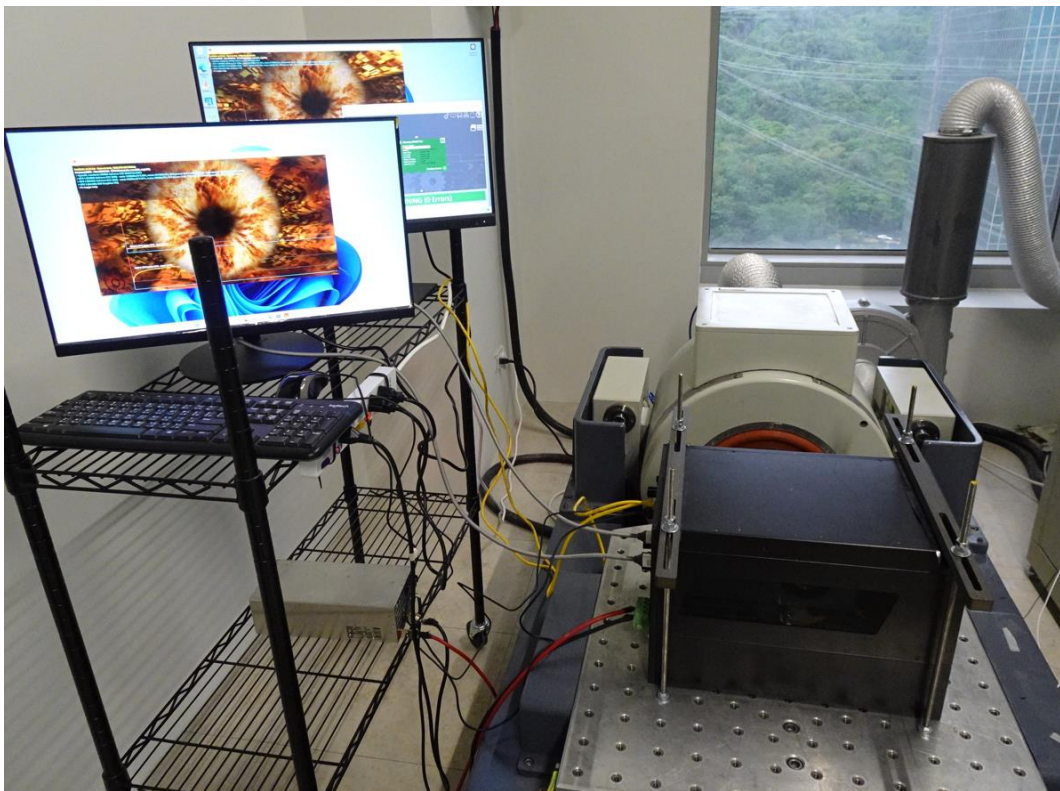
During Vibration/ Shock Test: X axis

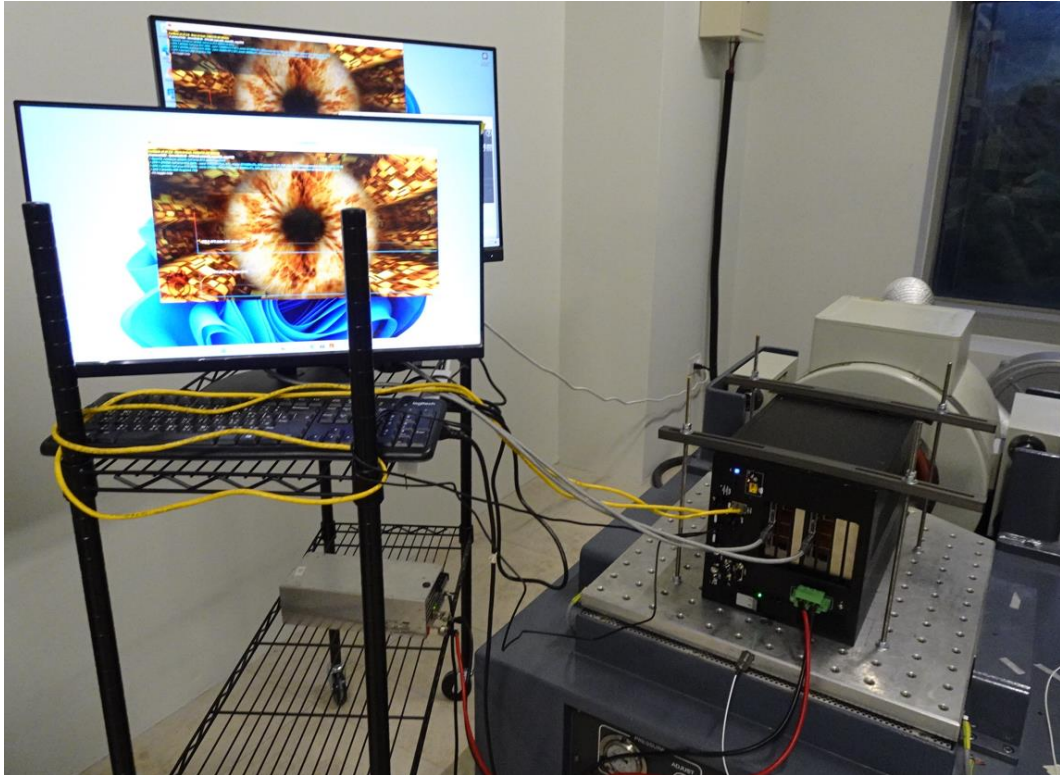
During Vibration/ Shock Test: Y axis

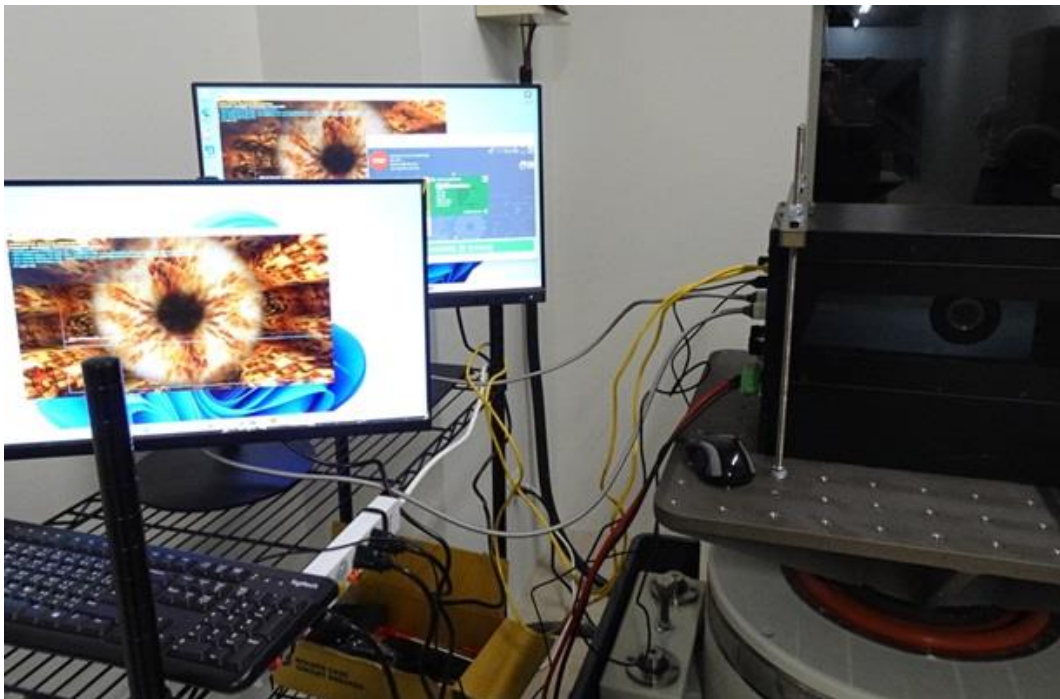
During Vibration/ Shock Test: Z axis

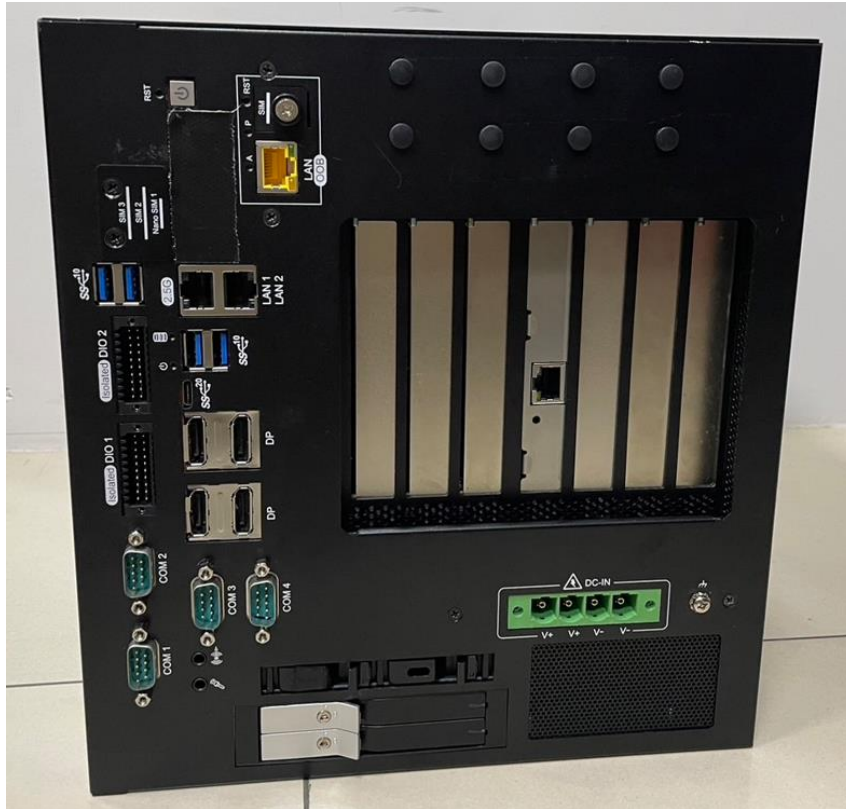
EUT Photographs (Including LAN card OOB-100 and PE-2001H for Temperature test)

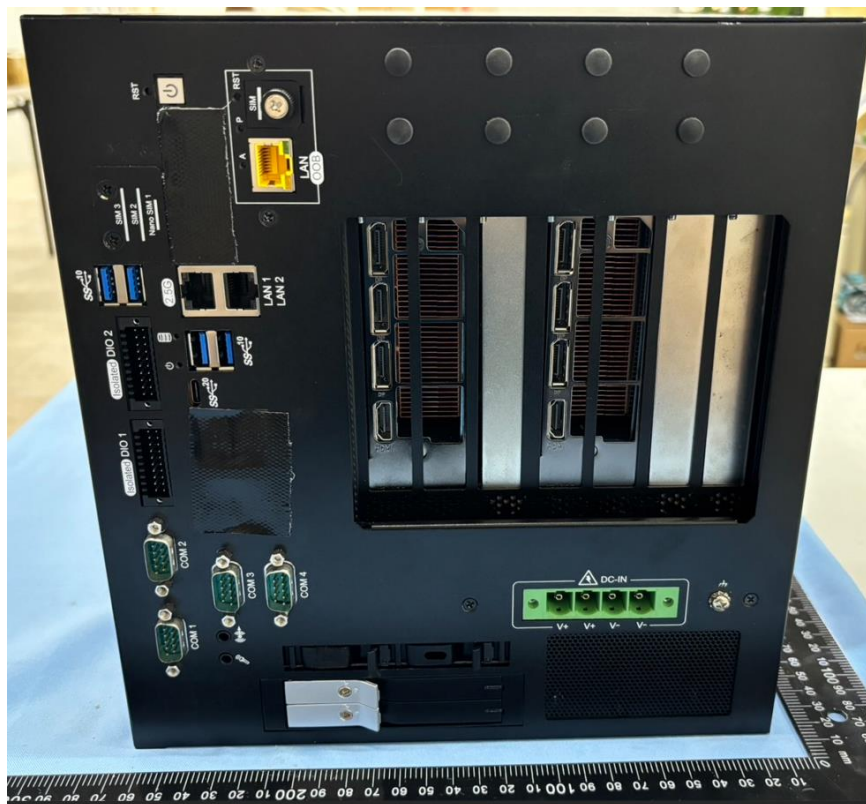
EUT Photographs (Including GPU for Vibration/ Shock Test)
