Report No.: VS-TV-121219-01

Test Report

Specimen	EAC-5000
Applicant Name	Vecow Co., Ltd.
Applicant Address	3F., No.10, Jiankang Rd., Zhonghe Dist., New Taipei City 23586, Taiwan

Test Report NO.	VS-TV-121219-01
Company name	Vecow Co., Ltd.
Company address	3F., No.10, Jiankang Rd., Zhonghe Dist., New Taipei City 23586, Taiwan
Product Name	Edge AI Computing System
Model No	EAC-5000
PCIe Expansion card	PE-8004MX
CPU	NVIDIA® Jetson AGX Orin™ 64GB
GPU	2048-core Ampere™ GPU with 56 Tensor Cores
RAM	64GB LPDDR5 DRAM
Quantity	1PCS
Series Model No	EAC-5000 Series, EAC-5XXXXXXXXXXXXXXXXX (“X” can be 0-9, A-Z, - or blank for marketing purpose)
Date of Test	Dec 15 ~ 18, 2023

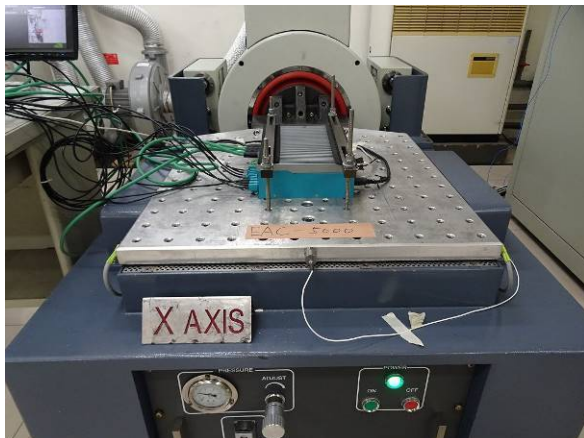
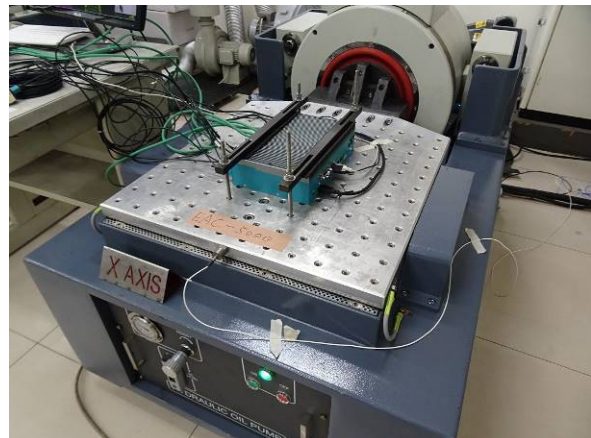
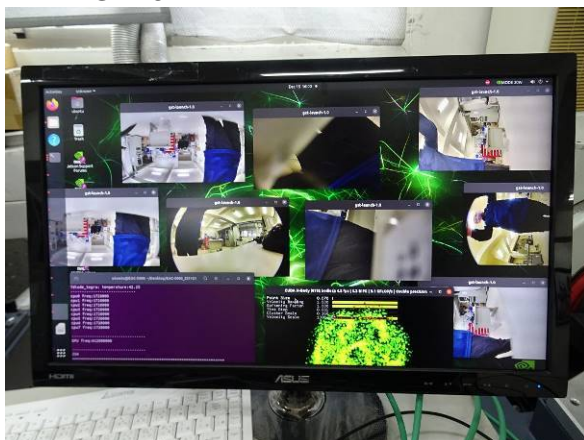
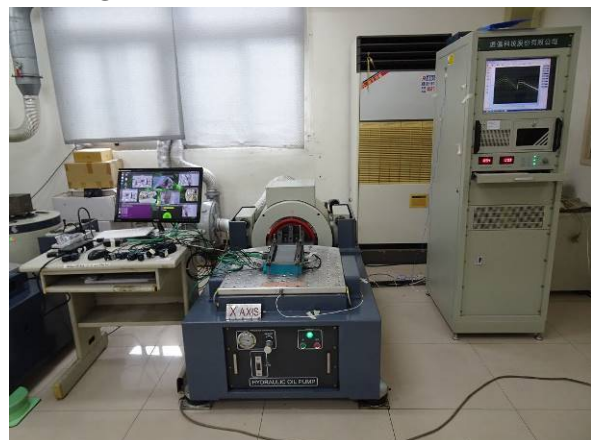
FIG 1.1: X axis direction mounted

FIG 1.2: X axis direction mounted

FIG 1.3: X axis direction mounted

FIG 1.4: X axis direction mounted

<p>Vibration Axial: X, Y, Z</p> <p>Single Axis Time: 1 hour</p> <p>Total Time: 3 hours</p> <p>FIG 1.1 ~ 1.4: X axis direction mounted</p> <p>FIG 2: X axis test screen</p> <p>FIG 3: Y axis direction mounted</p> <p>FIG 4: Y axis test screen</p> <p>FIG 5.1 ~ 5.4: Z axis direction mounted</p> <p>FIG 6: Z axis test screen</p>					Vertical (Z)		Transverse(X)		Longitudinal(Y)		Frequency, Hz	PSD g ² /Hz	Frequency, Hz	PSD g ² /Hz	Frequency, Hz	PSD g ² /Hz	10	0.01500	10	0.00013	10	0.00650	40	0.01500	20	0.00065	20	0.00650	500	0.00015	30	0.00065	120	0.00020	rms =1.04G		78	0.00002	121	0.00300	79	0.00019	200	0.00300	120	0.00019	240	0.00150	500	0.00001	340	0.00003	rms =0.204 G		500	0.00015	rms =0.740 G	
Vertical (Z)		Transverse(X)		Longitudinal(Y)																																																							
Frequency, Hz	PSD g ² /Hz	Frequency, Hz	PSD g ² /Hz	Frequency, Hz	PSD g ² /Hz																																																						
10	0.01500	10	0.00013	10	0.00650																																																						
40	0.01500	20	0.00065	20	0.00650																																																						
500	0.00015	30	0.00065	120	0.00020																																																						
rms =1.04G		78	0.00002	121	0.00300																																																						
		79	0.00019	200	0.00300																																																						
		120	0.00019	240	0.00150																																																						
		500	0.00001	340	0.00003																																																						
		rms =0.204 G		500	0.00015	rms =0.740 G																																																					
Test Result	<p>Appearance: Pass, No external physical damage</p> <p>Function: Pass.</p>

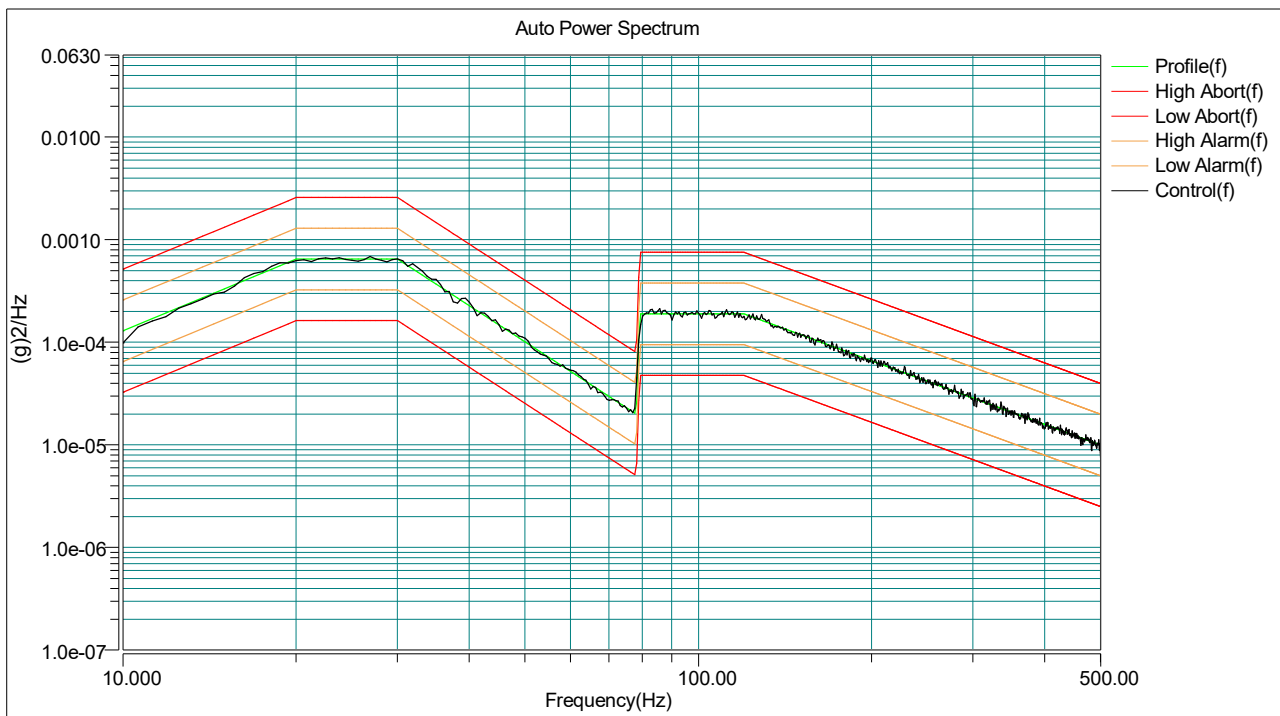
FIG 2: X axis test screen

Current Level: 100 %

Demand RMS:0.203188 g

Control RMS: 0.203558 g

Frame Time:1.600000 (s)

Lines:800

dF:0.625000 Hz

DOF:300

Test Elapsed:01:00:19

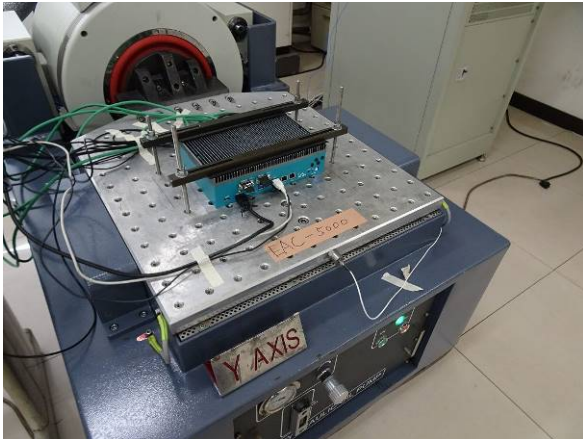
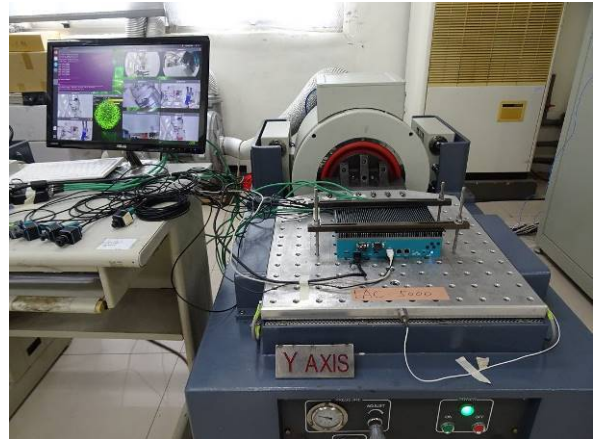
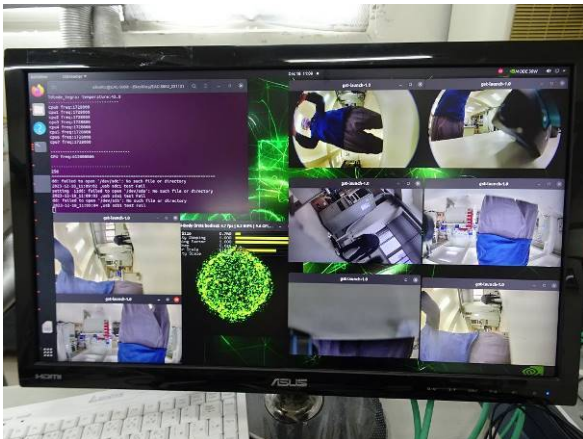
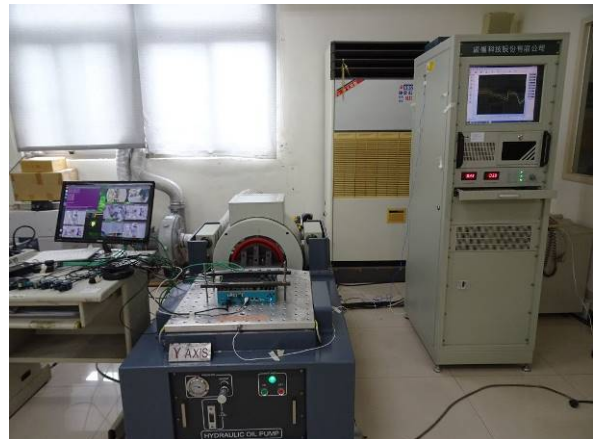
FIG 3.1: Y axis direction mounted

FIG 3.2: Y axis direction mounted

FIG 3.3: Y axis direction mounted

FIG 3.4: Y axis direction mounted

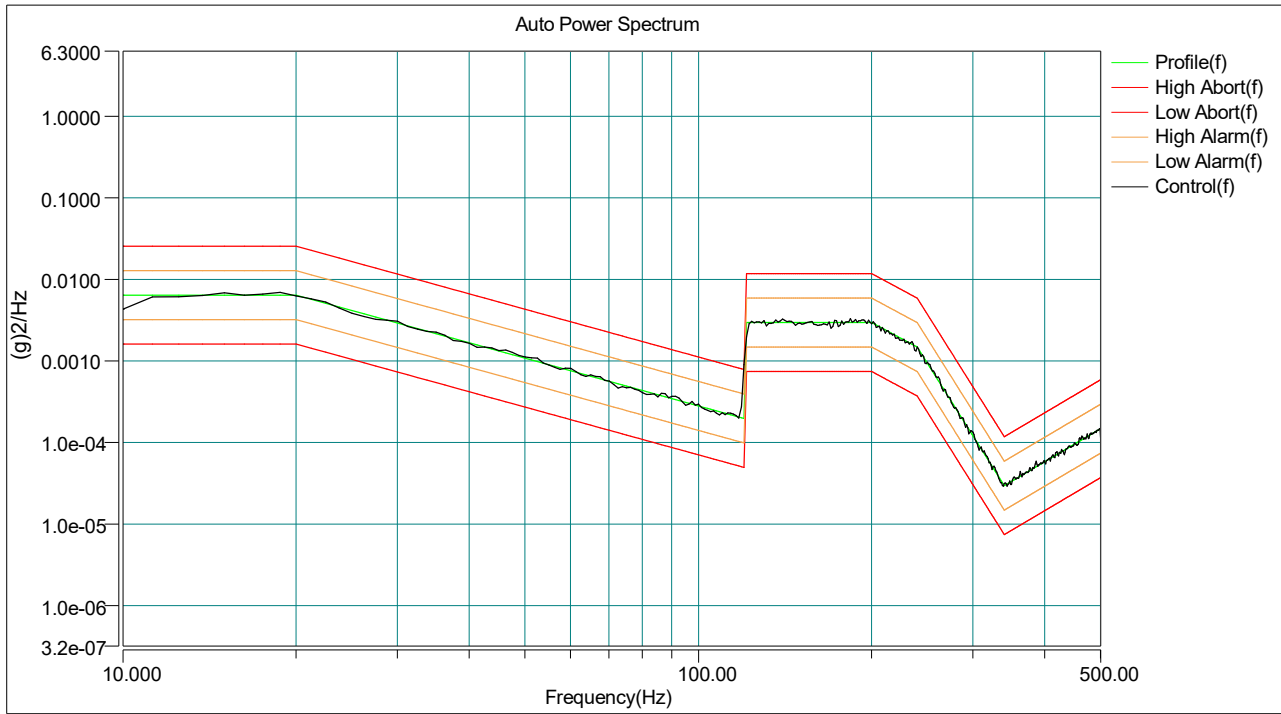
FIG 4: Y axis test screen

Current Level: 100 %

Demand RMS:0.739402 g

Control RMS: 0.737464 g

Frame Time:0.800000 (s)

Lines:400

dF:1.250000 Hz

DOF:300

Test Elapsed:01:00:19

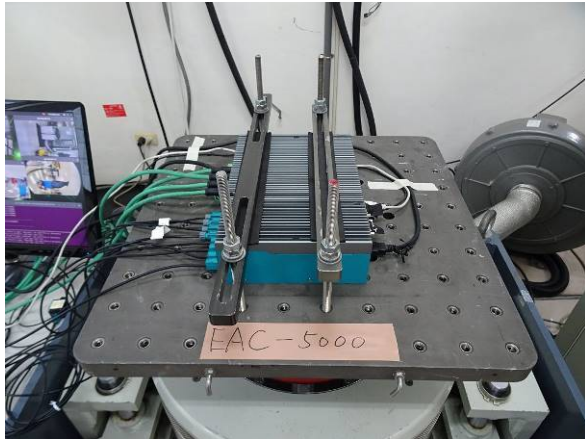
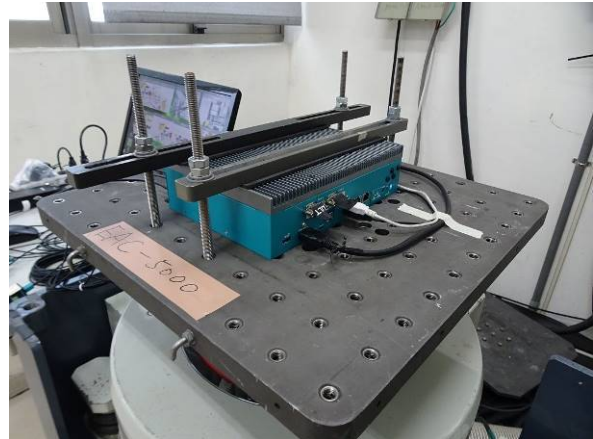
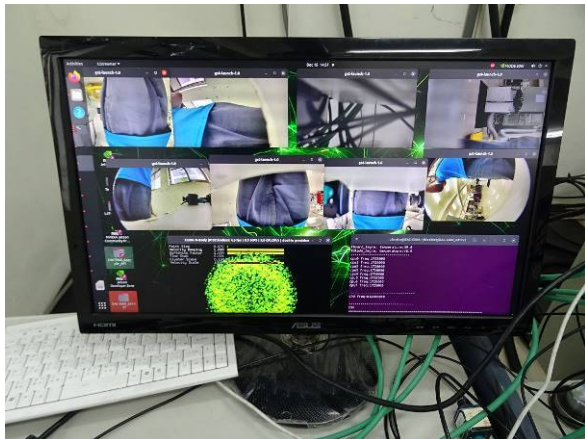
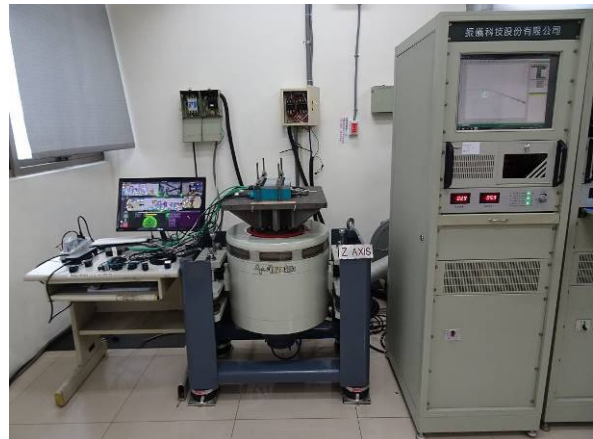
FIG 5.1: Z axis direction mounted

FIG 5.2: Z axis direction mounted

FIG 5.3: Z axis direction mounted

FIG 5.4: Z axis direction mounted

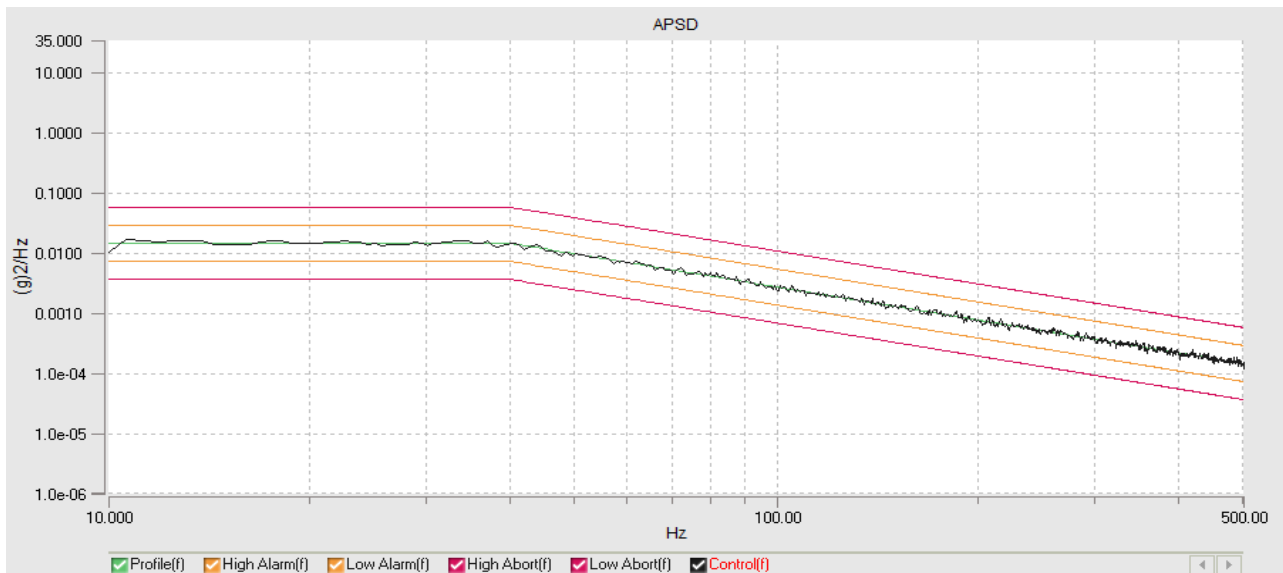
FIG 6: Z axis test screen

Current Level: 100.00 %

Demand RMS: 1.043 g

Control RMS: 1.046 g

Frame Time: 1.6000 (s)

Lines: 800

dF: 0.6 Hz

DOF: 312

Current Level Time: 01:00:00

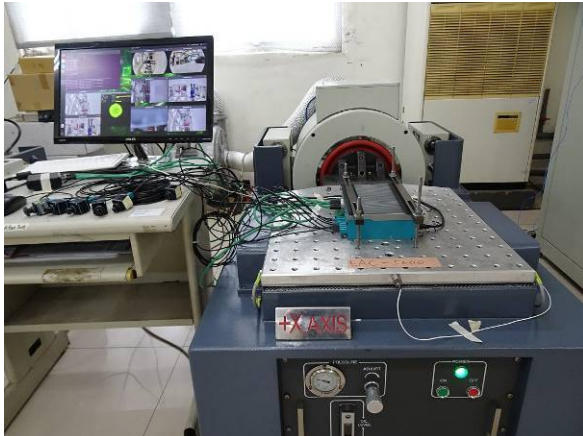
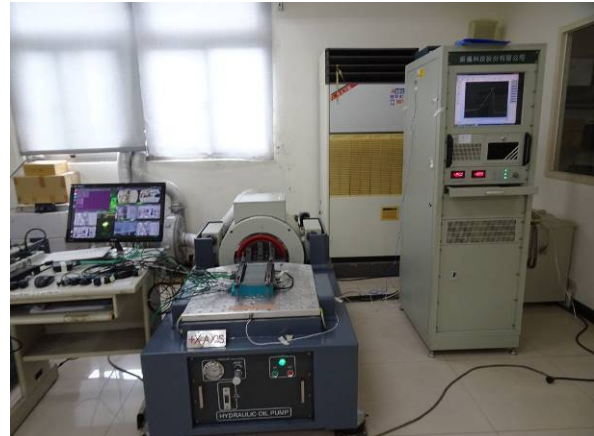
FIG 7.1: +X axis direction mounted

FIG 7.2: +X axis direction mounted

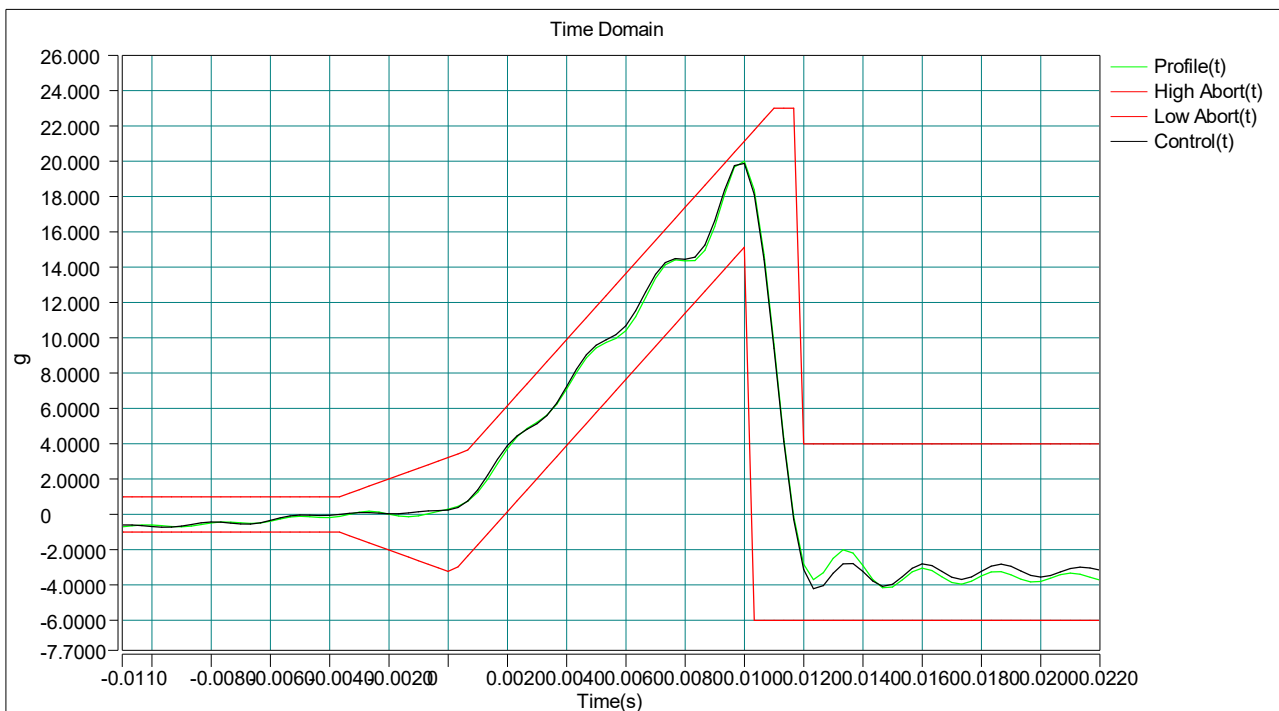
FIG.8 : +X Axis Test screen.

Shock Type:Final Peak Saw Tooth

Amplitude:20.000000 g

Pulse Duration:11.000001 ms

Demand peak:20.000000 g

Control peak:19.880947 g

Tested pulses: 6

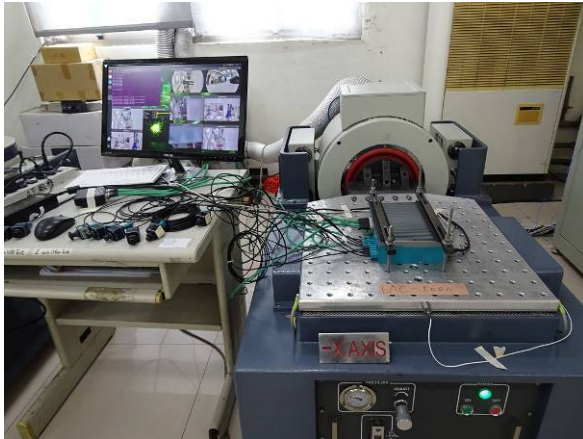
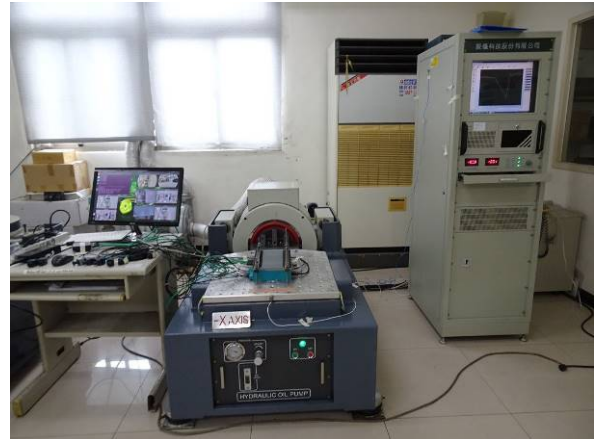
FIG 9.1: -X axis direction mounted

FIG 9.2: -X axis direction mounted

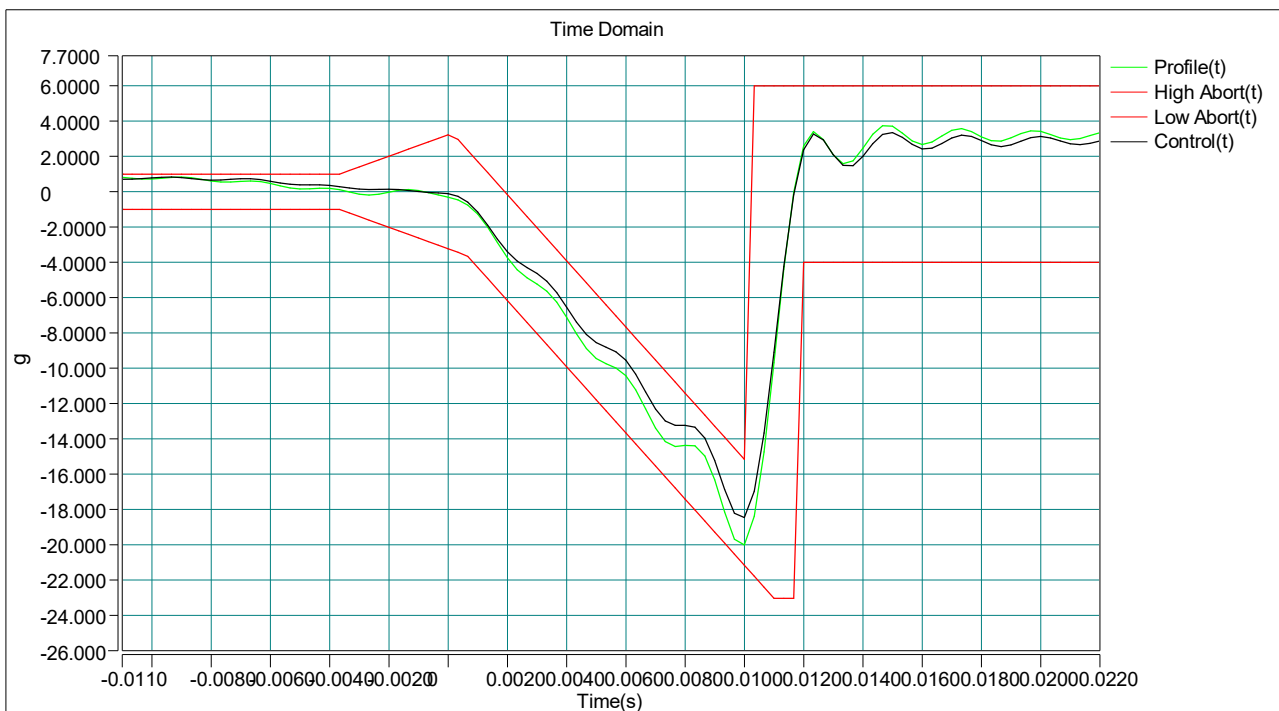
FIG.10 : -X Axis Test screen.

Shock Type:Final Peak Saw Tooth

Amplitude:20.000000 g

Pulse Duration:11.000001 ms

Demand peak:20.000000 g

Control peak:18.448366 g

Tested pulses: 6

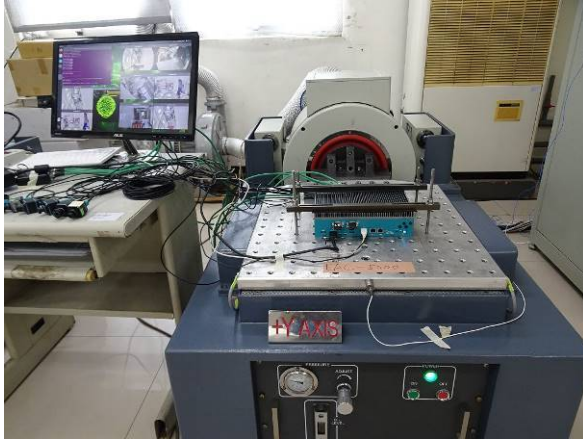
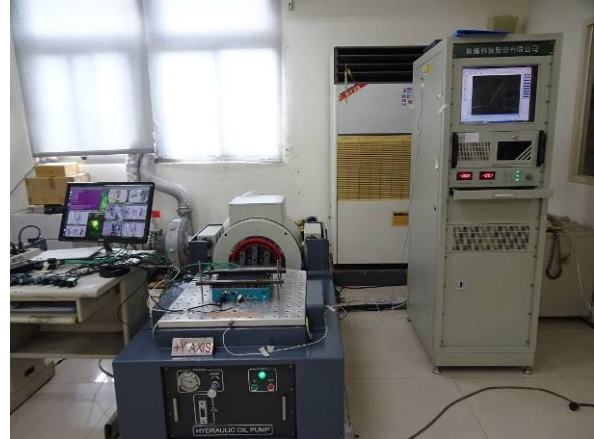
FIG 11.1: +Y axis direction mounted

FIG 11.2: +Y axis direction mounted

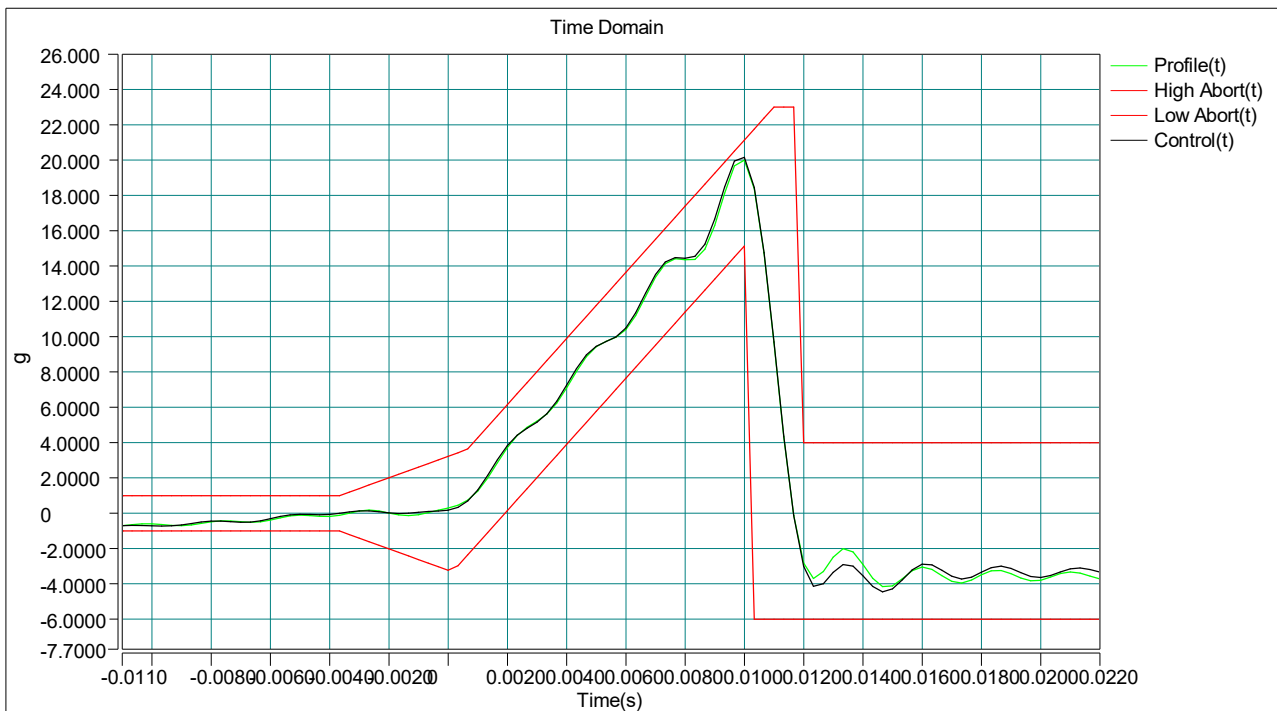
FIG.12 : +Y Axis Test screen.

Shock Type:Final Peak Saw Tooth

Amplitude:20.000000 g

Pulse Duration:11.000001 ms

Demand peak:20.000000 g

Control peak:20.166544 g

Tested pulses: 6

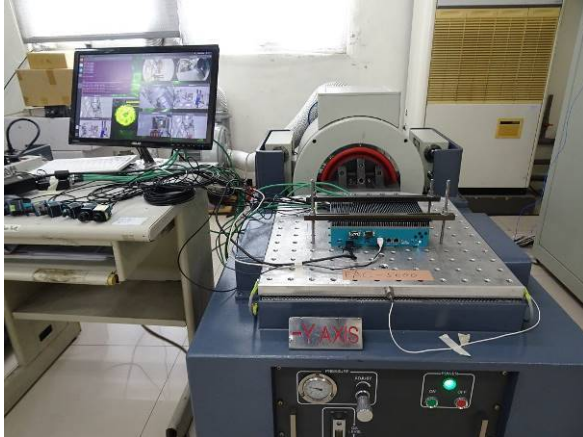
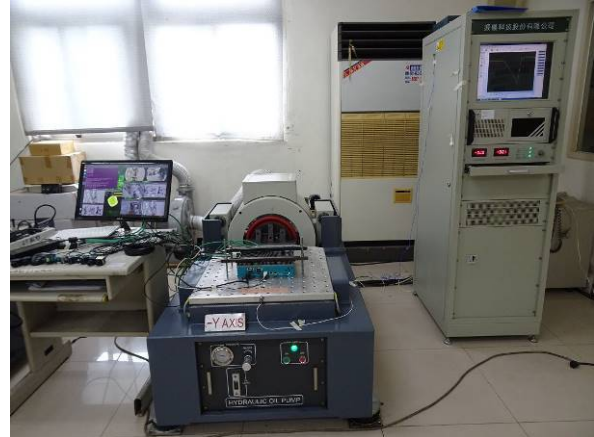
FIG 13.1: -Y axis direction mounted

FIG 13.2: -Y axis direction mounted

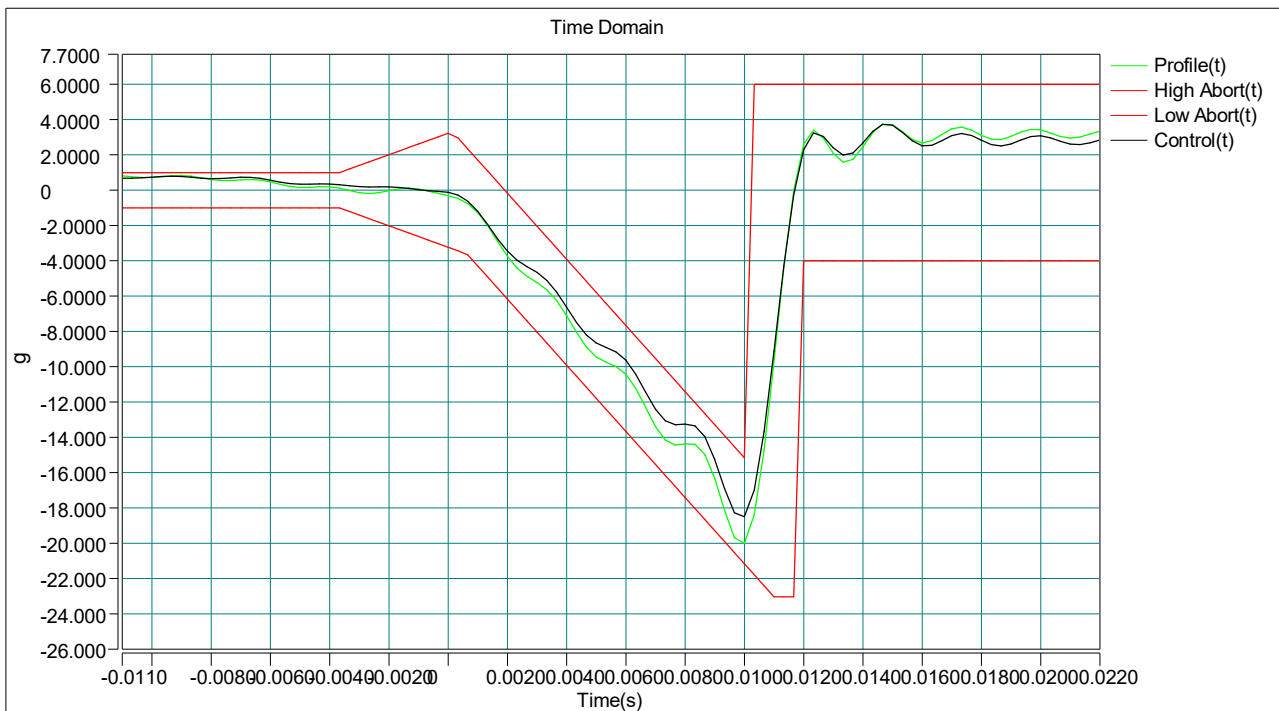
FIG.14 : -Y Axis Test screen.

Shock Type:Final Peak Saw Tooth

Amplitude:20.000000 g

Pulse Duration:11.000001 ms

Demand peak:20.000000 g

Control peak:18.488779 g

Tested pulses: 8

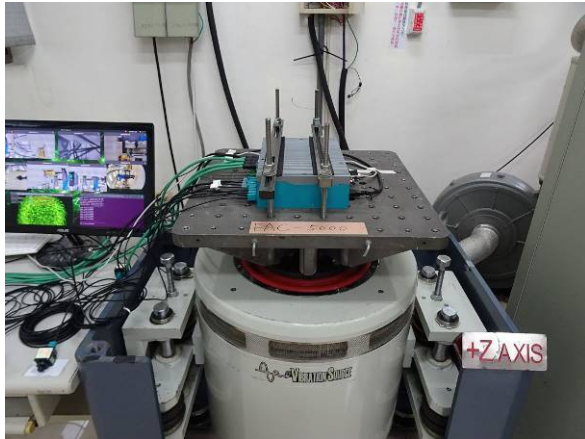
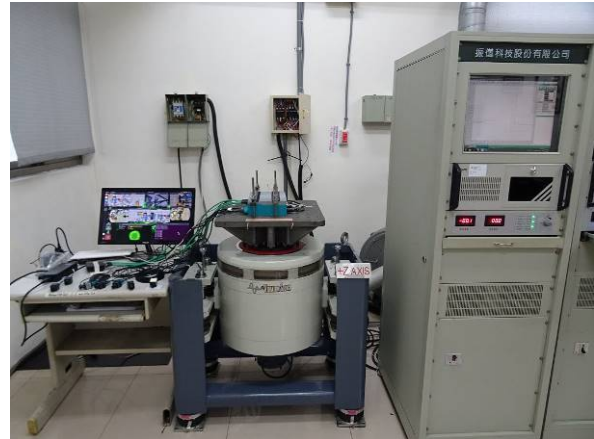
FIG 15.1: +Z axis direction mounted

FIG 15.2: +Z axis direction mounted

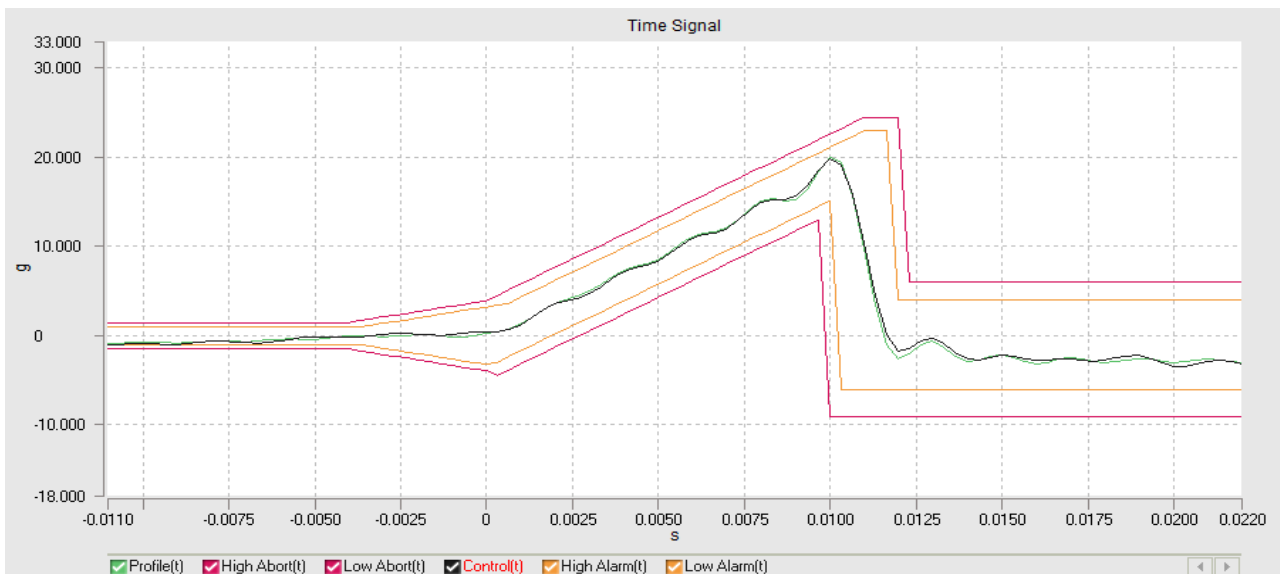
FIG.16 : +Z Axis Test screen.

Shock Type:Final Peak Saw Tooth

Mag:20.00 g

Pulse Duration:11 ms

Demand peak:20.000 g

Control peak:19.907 g

Current Pulses: 3

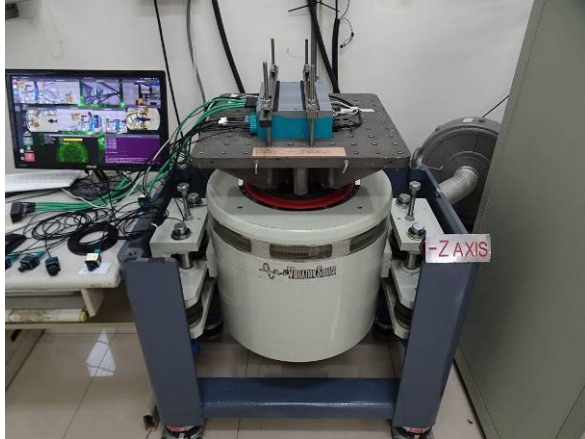
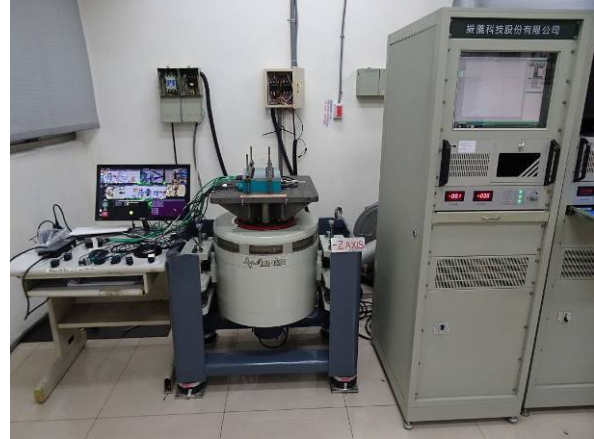
FIG 17.1: -Z axis direction mounted

FIG 17.2: -Z axis direction mounted

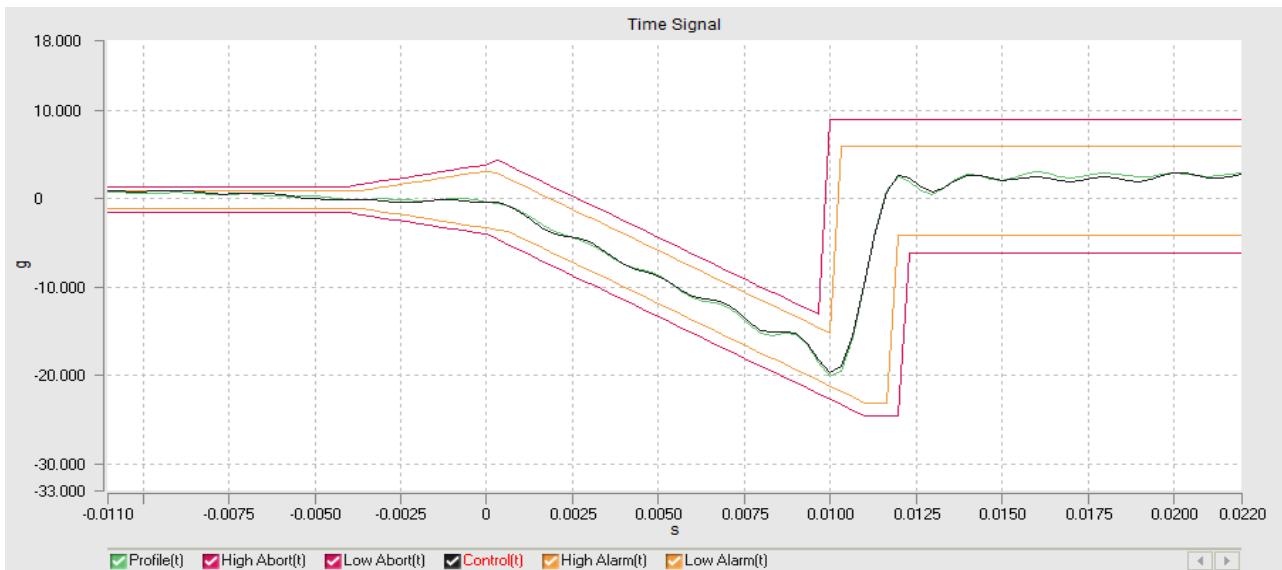
FIG.18 : -Z Axis Test screen.

Shock Type:Final Peak Saw Tooth

Mag:20.00 g

Pulse Duration:11 ms

Demand peak:20.000 g

Control peak:19.541 g

Current Pulses: 3

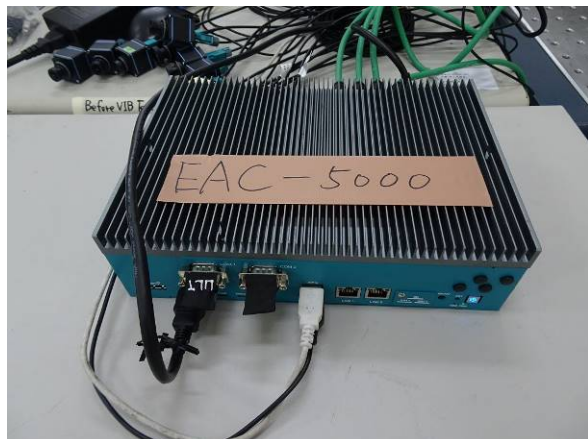
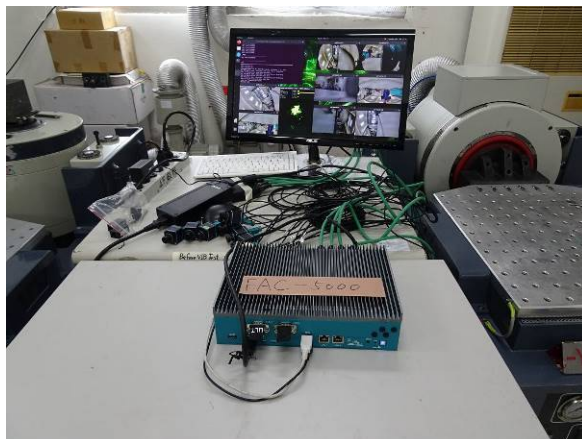
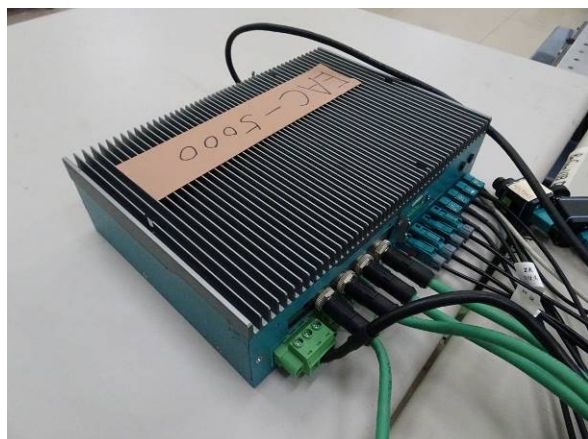
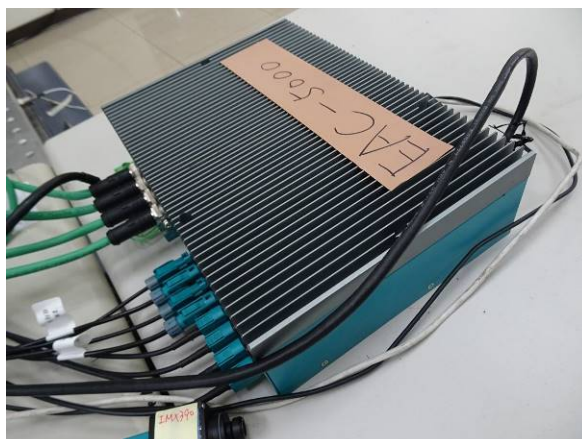
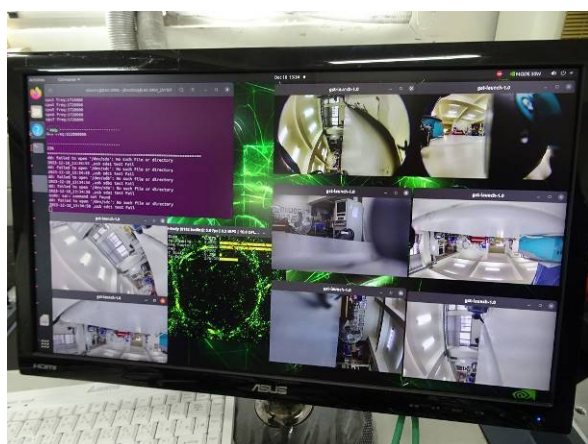
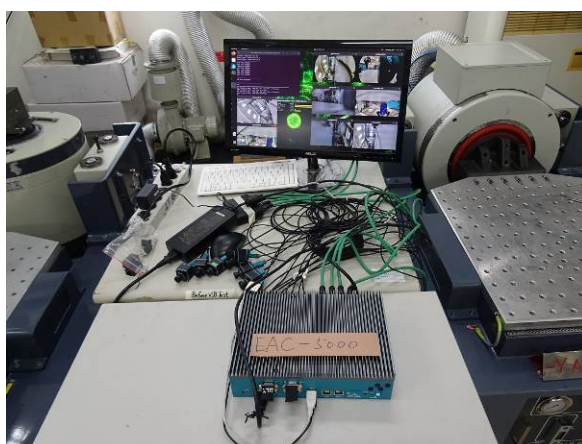
FIG.19.1 ~ 19.6

Posterior check.

Test Result	Appearance: Pass, No external physical damage Function: Pass.	
Test Conducted By		Report Prepared By
<i>Archie Chen</i> <i>Archie Chen</i>		Jane <i>Jane</i>
